**FAILURE CHARACTERISTICS OF SCS-6/Ti-24Al-11Nb
COMPOSITE WITH A CIRCULAR HOLE
AT ROOM AND ELEVATED TEMPERATURES**

THESIS

**Joseph E. Overbeck, Captain, USAF
AFIT/GAE/ENY/91D-8**

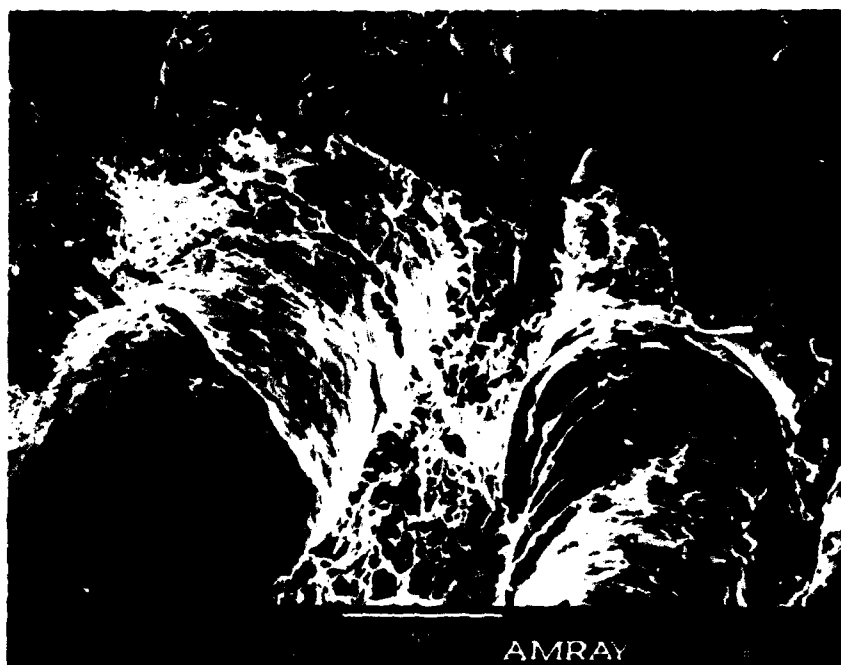
Figure 47. Fracture surface of notched $[0^\circ]_s$ specimen near hole.

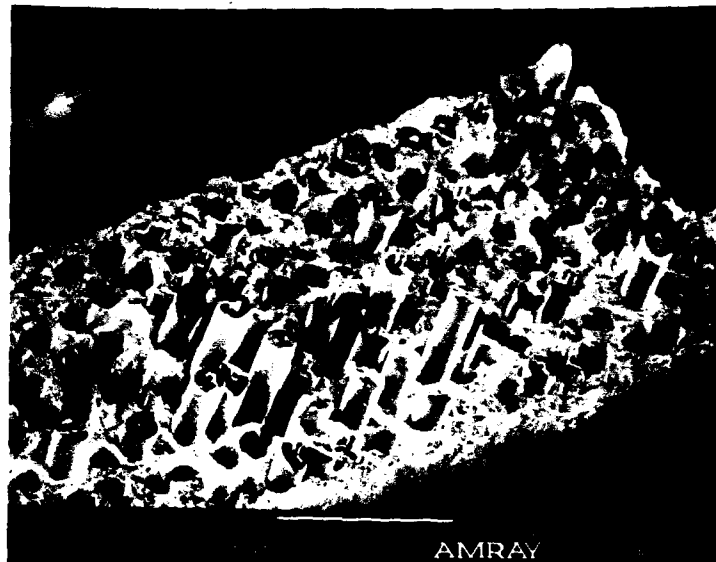
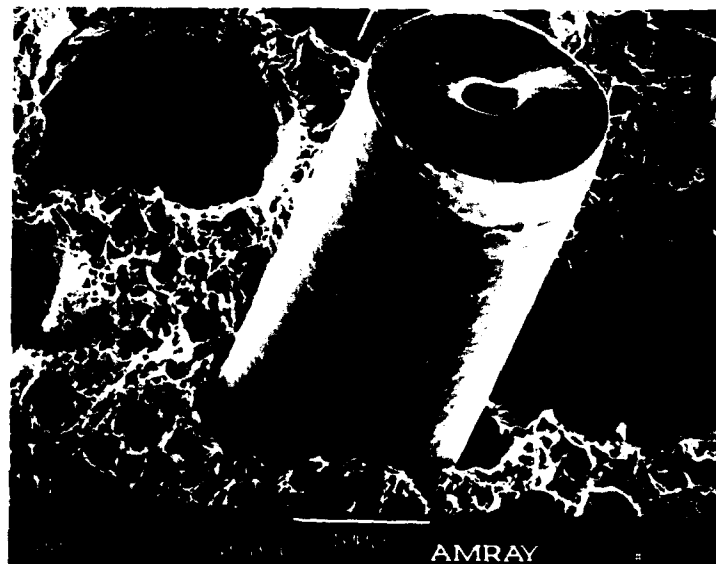
Figure 48. Fracture surface of notched $[0^\circ]_8$ specimen away from hole.

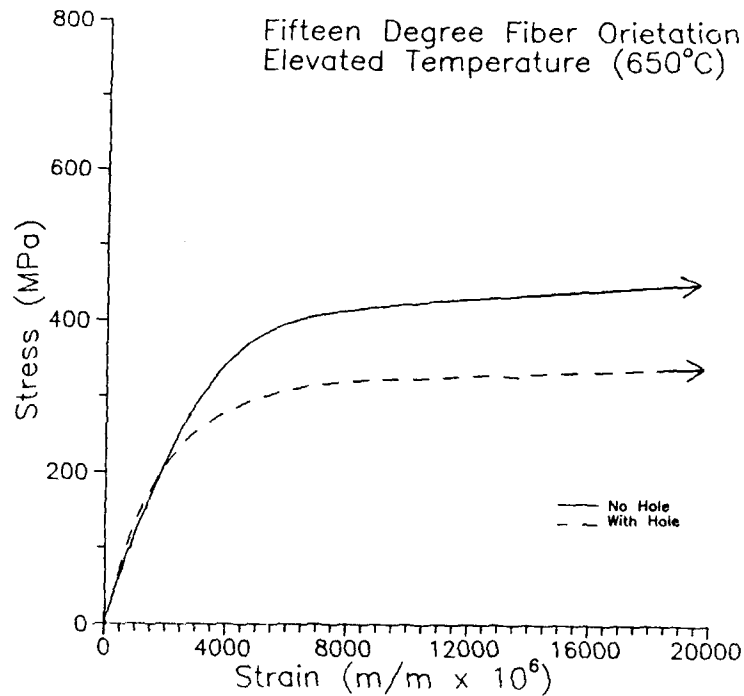
Figure 49. Stress-strain plot of $[15^\circ]_8$ layup at 650°C.

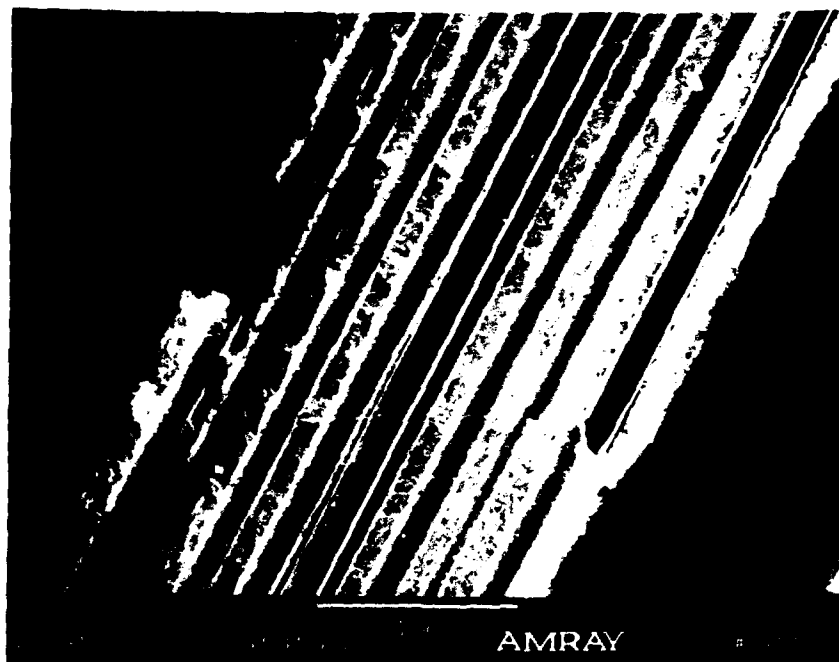
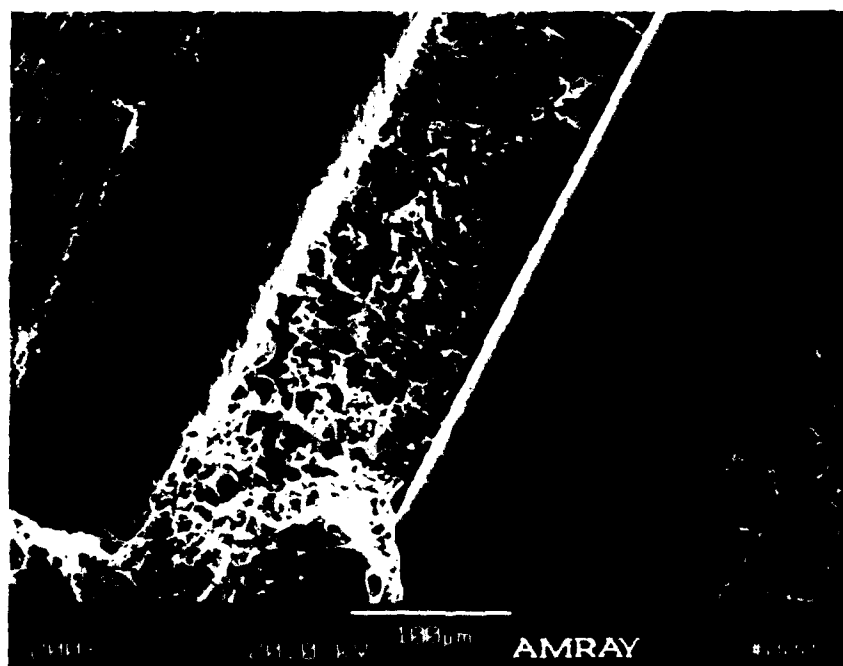
Figure 51. Fracture surface of unnotched $[15^\circ]_s$ specimen.

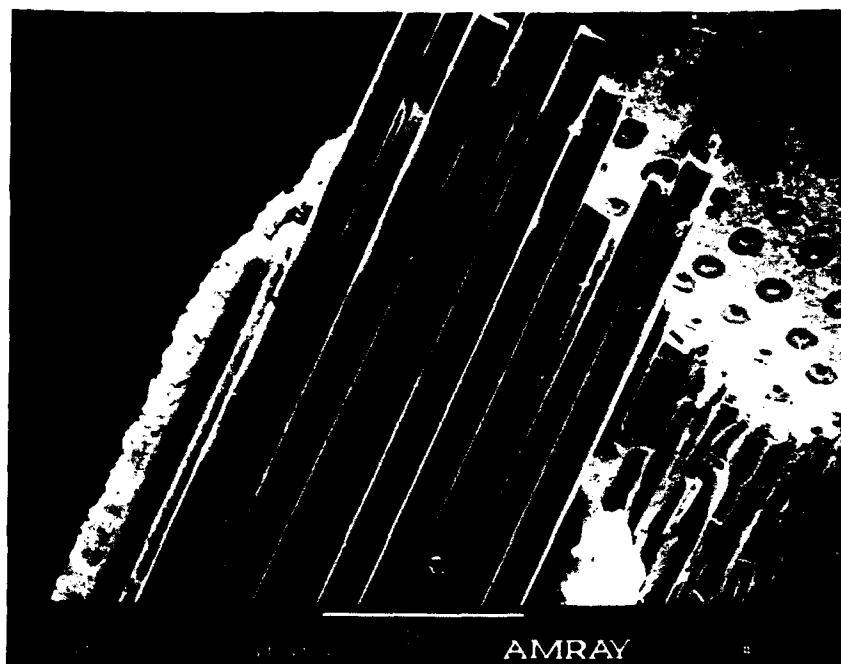
Figure 52. Fracture surface of notched $[15^\circ]_B$ specimen near hole.

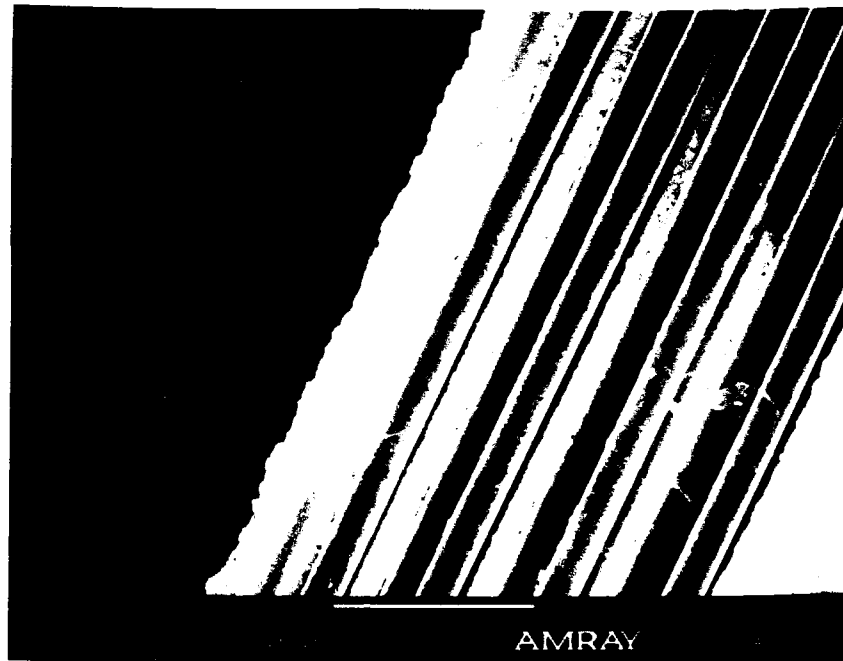
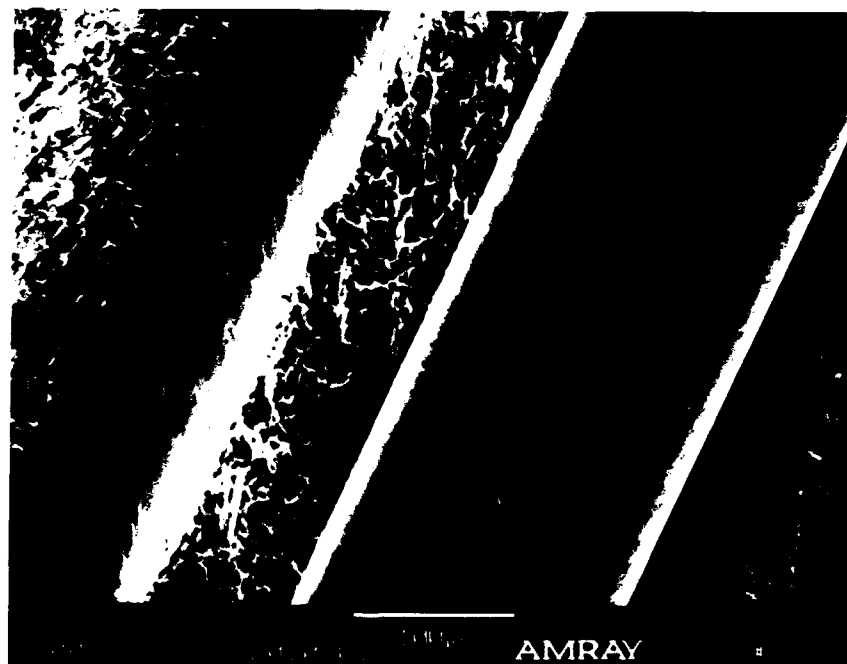
Figure 53. Fracture surface of notched $[15^\circ]_8$ specimen away from hole.

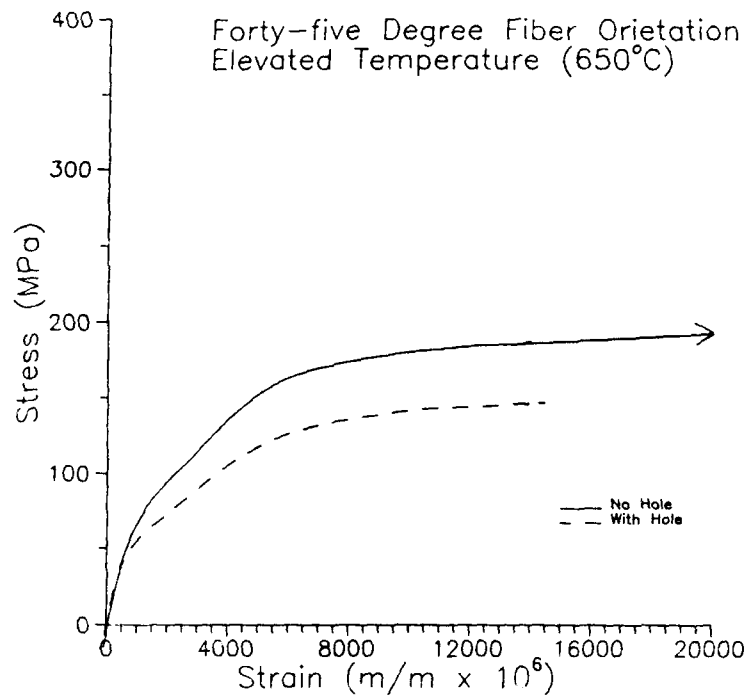
Figure 54. Stress-strain plot of $[45^\circ]_8$ layup of 650°C.

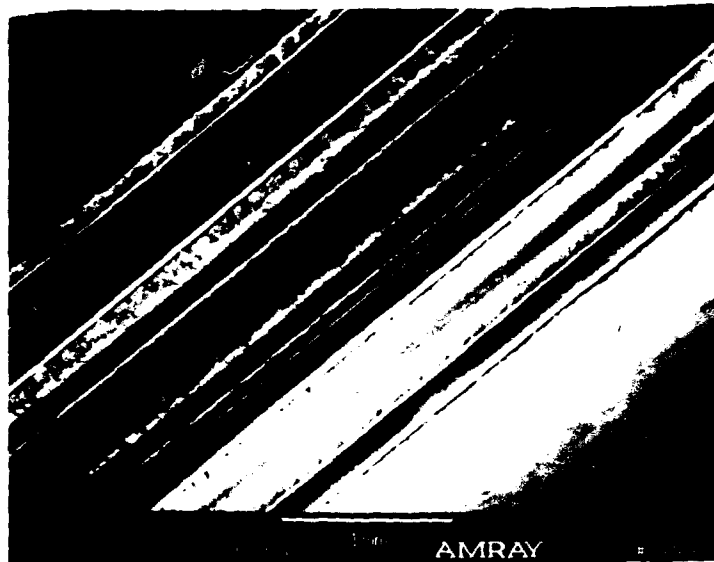
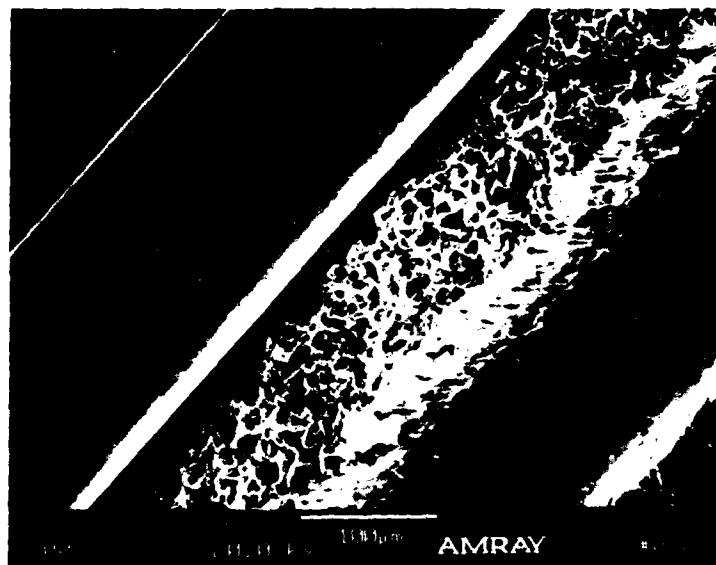
Figure 56. Fracture surface of unnotched $[45^\circ]_8$ specimen.

the width of the specimen except at the edge where some delamination occurred. The magnified views of the fracture surfaces, Figures 56, 57, and 58, show extensive separation of the fibers and matrix at the fracture and ductile fracture of the matrix. As with the $[15^\circ]_8$ specimens, the fiber surfaces are clean and undamaged indicating a weak fiber/matrix interface bond. The fiber channels of the $[45^\circ]_8$ layup are less cracked than those of the $[15^\circ]_8$ layup, but there was less plastic deformation of the $[45^\circ]_8$ specimens prior to failure. The notched and unnotched fracture surfaces are the same except for the evidence of greater plastic deformation of the unnotched specimen.

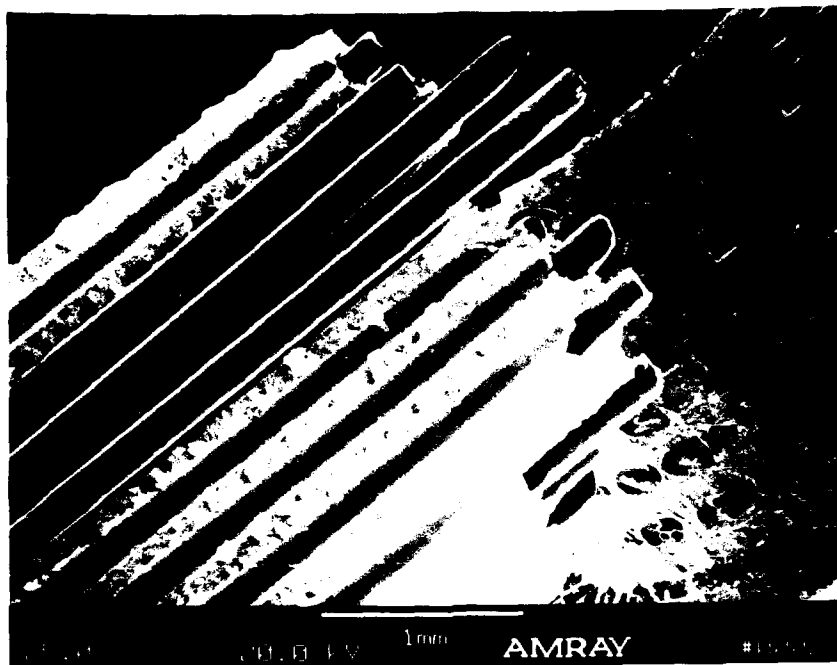
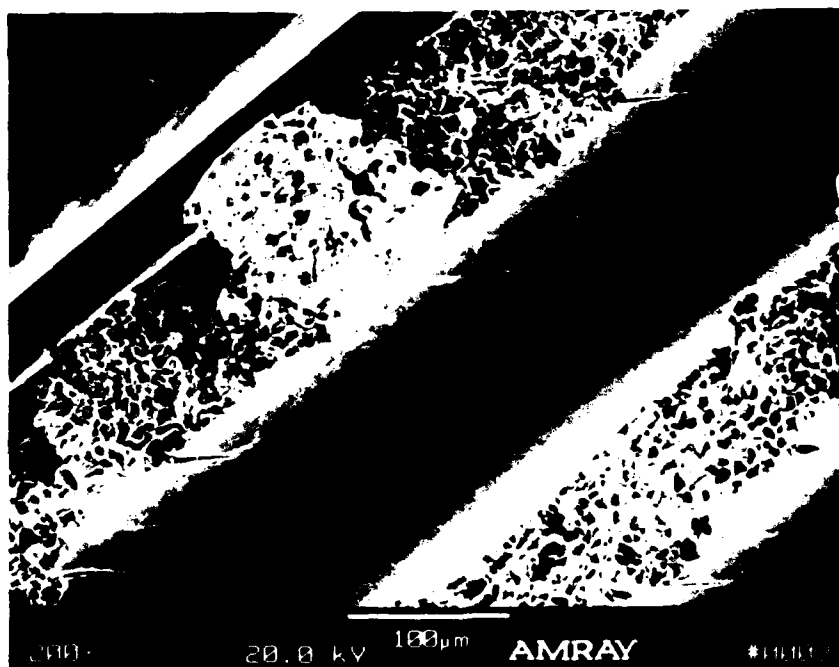
Figure 57. Fracture surface of notched $[45^\circ]_s$ specimen near hole.

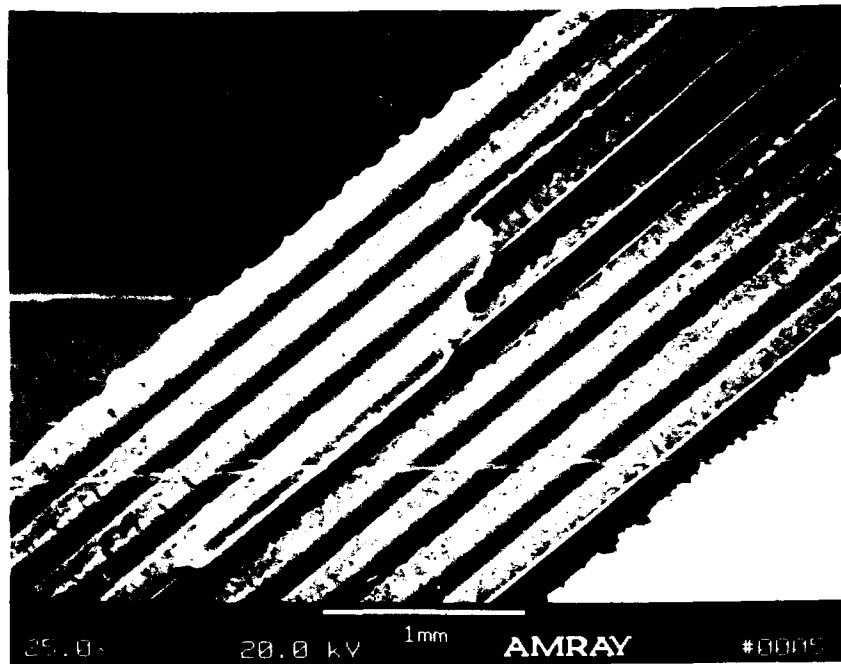
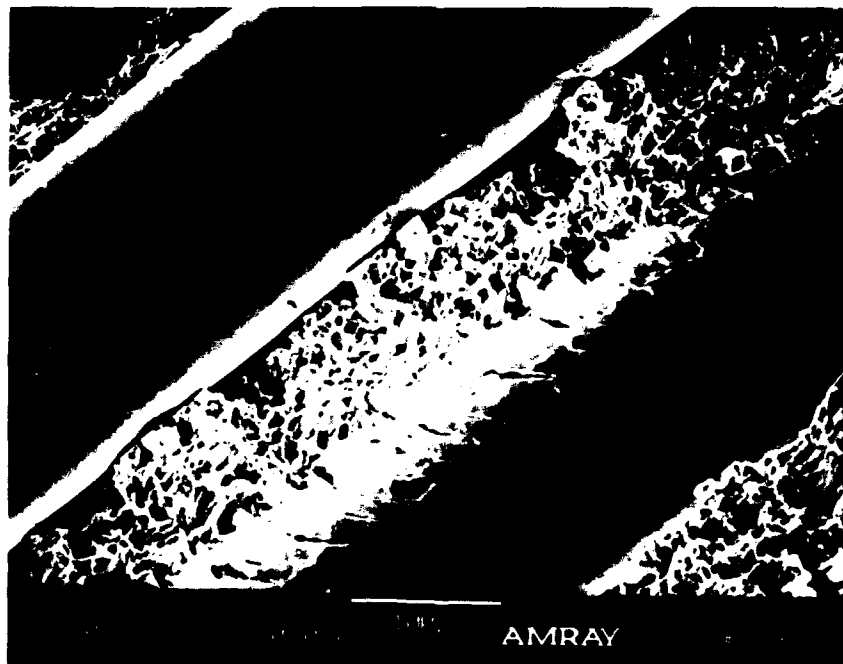
Figure 58. Fracture surface of notched $[45^\circ]_8$ specimen away from hole.

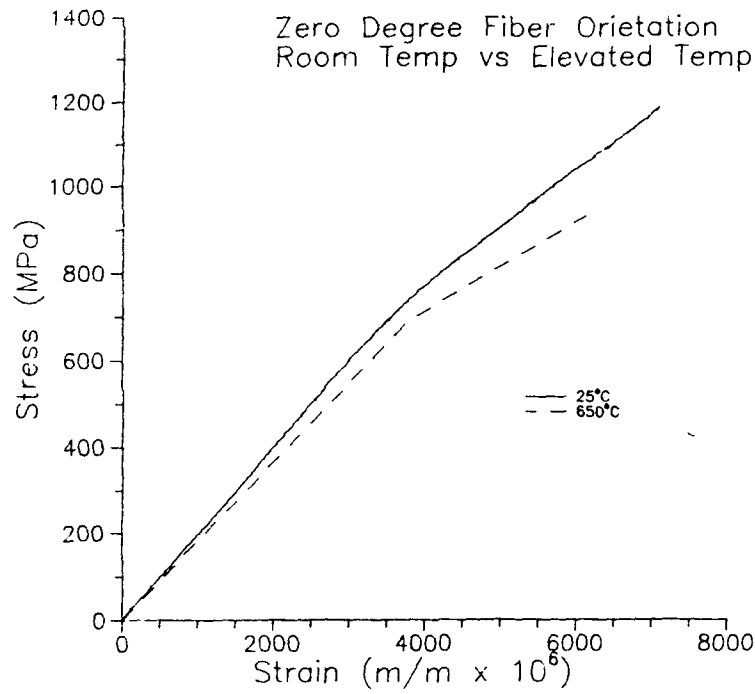
Figure A1. Stress-strain plot, unnotched $[0^\circ]_8$ specimen.

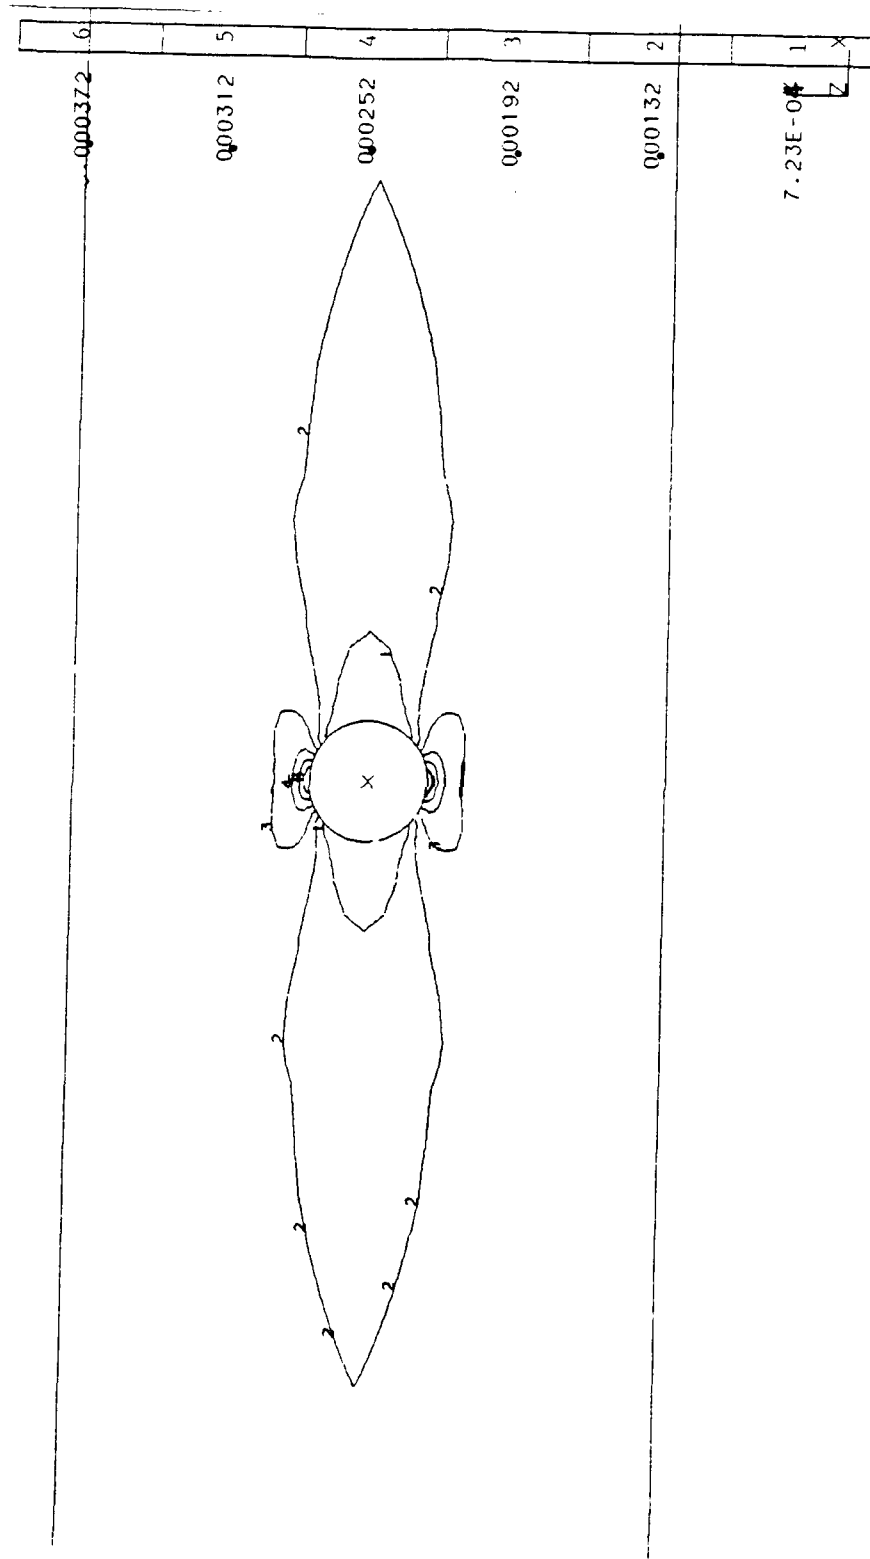
Figure B1. Strain at predicted yielding. Room temperature, $[0^\circ]_k$ layup.

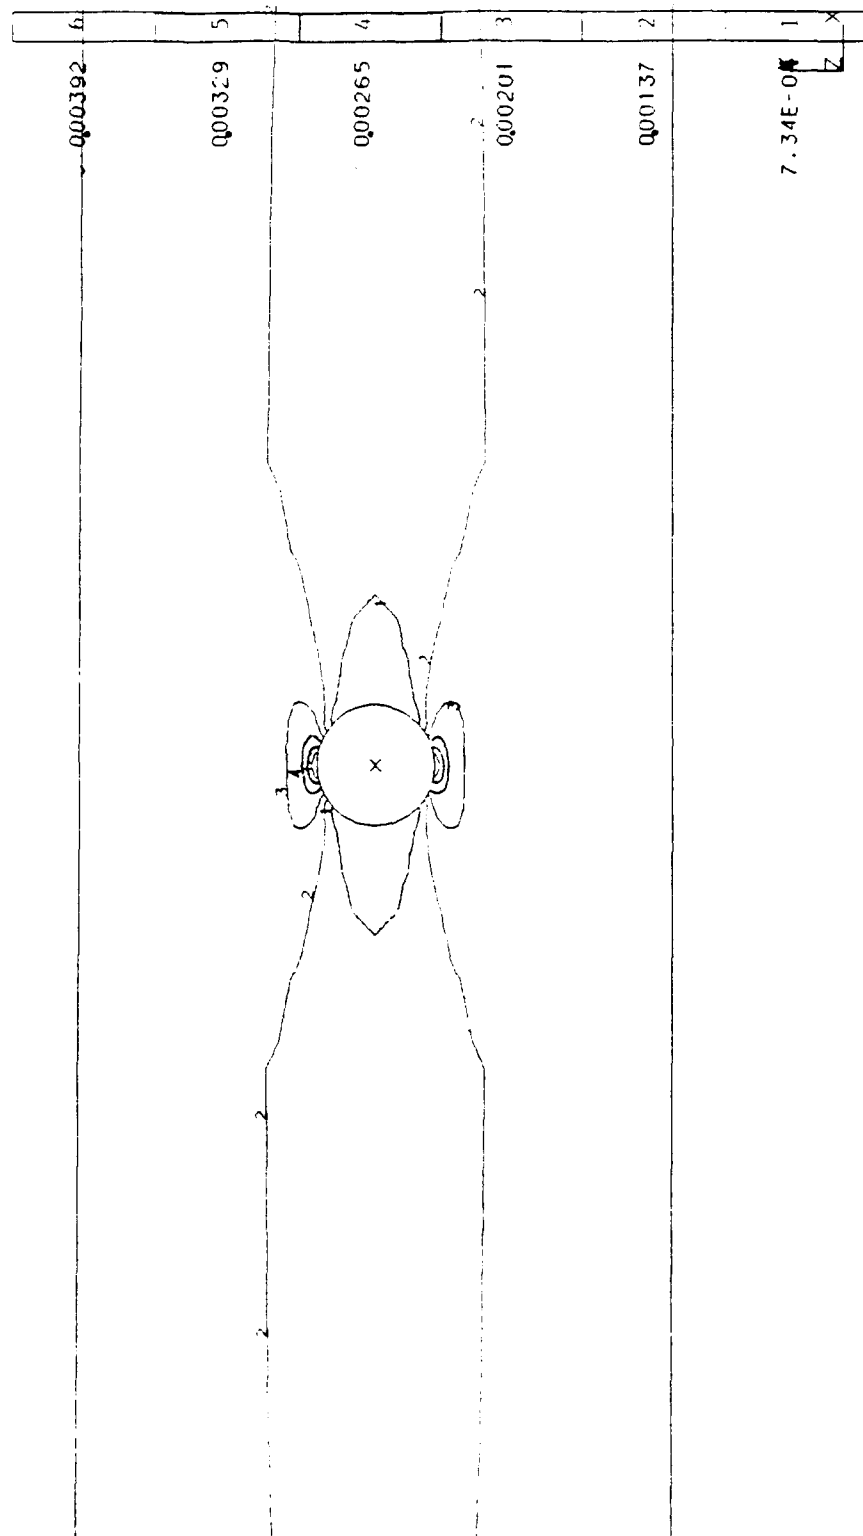
Figure B2. Strain at predicted yielding. Elevated temperature, $[0^\circ]_k$ layup.

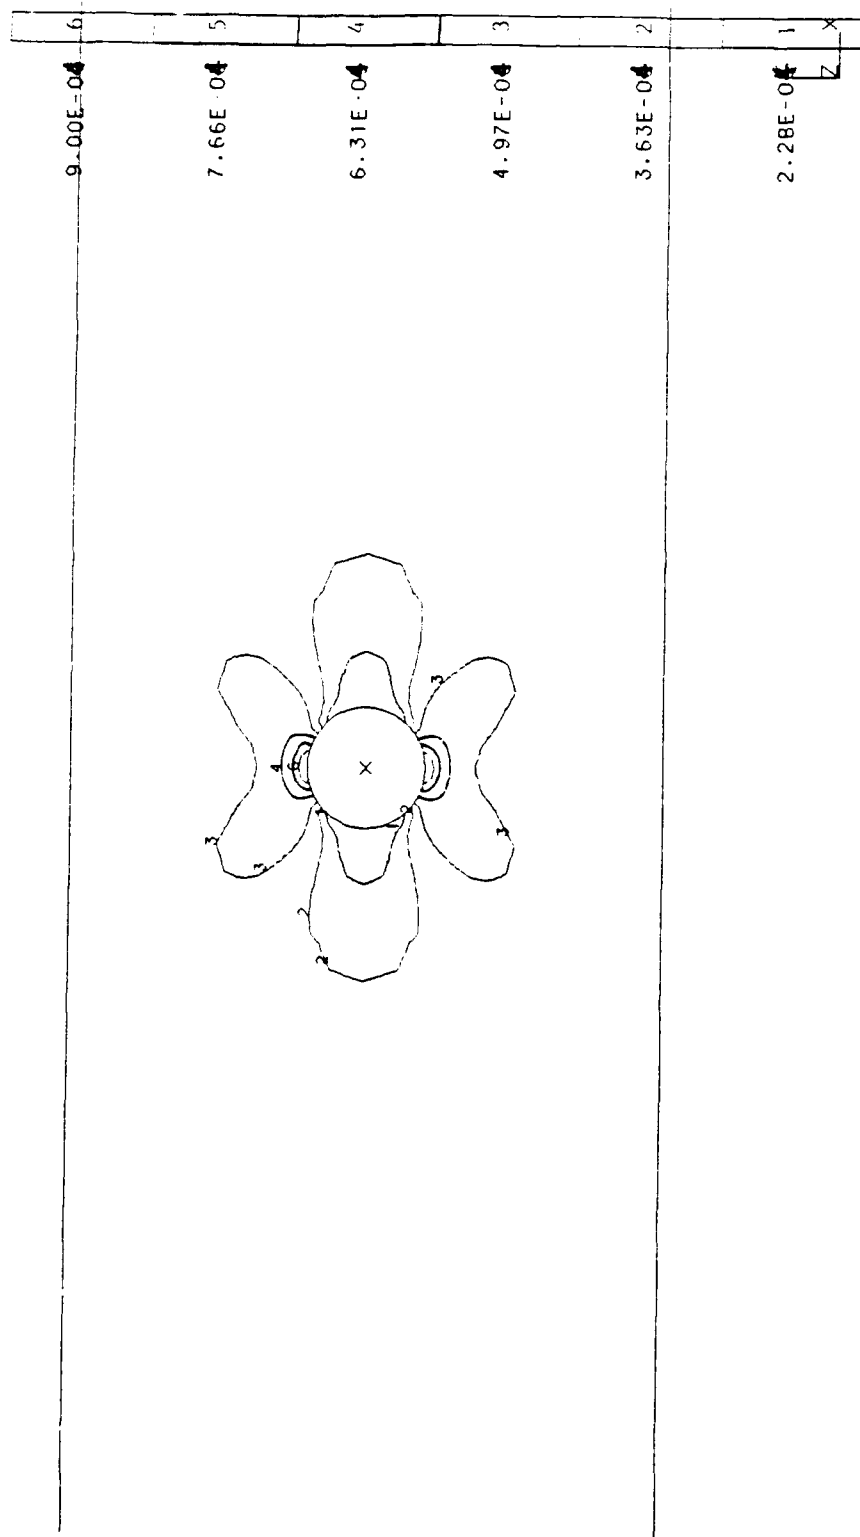
Figure B6. Strain at predicted yielding. Elevated temperature, $[45^\circ]_8$ layout.
